**NISTIR 4868**

# **Interim Report: Preliminary Sitewide Survey of Reinforced Concrete Structural Deterioration at NIST**

**Lawrence I. Knab  
Research Civil Engineer**

August 1992

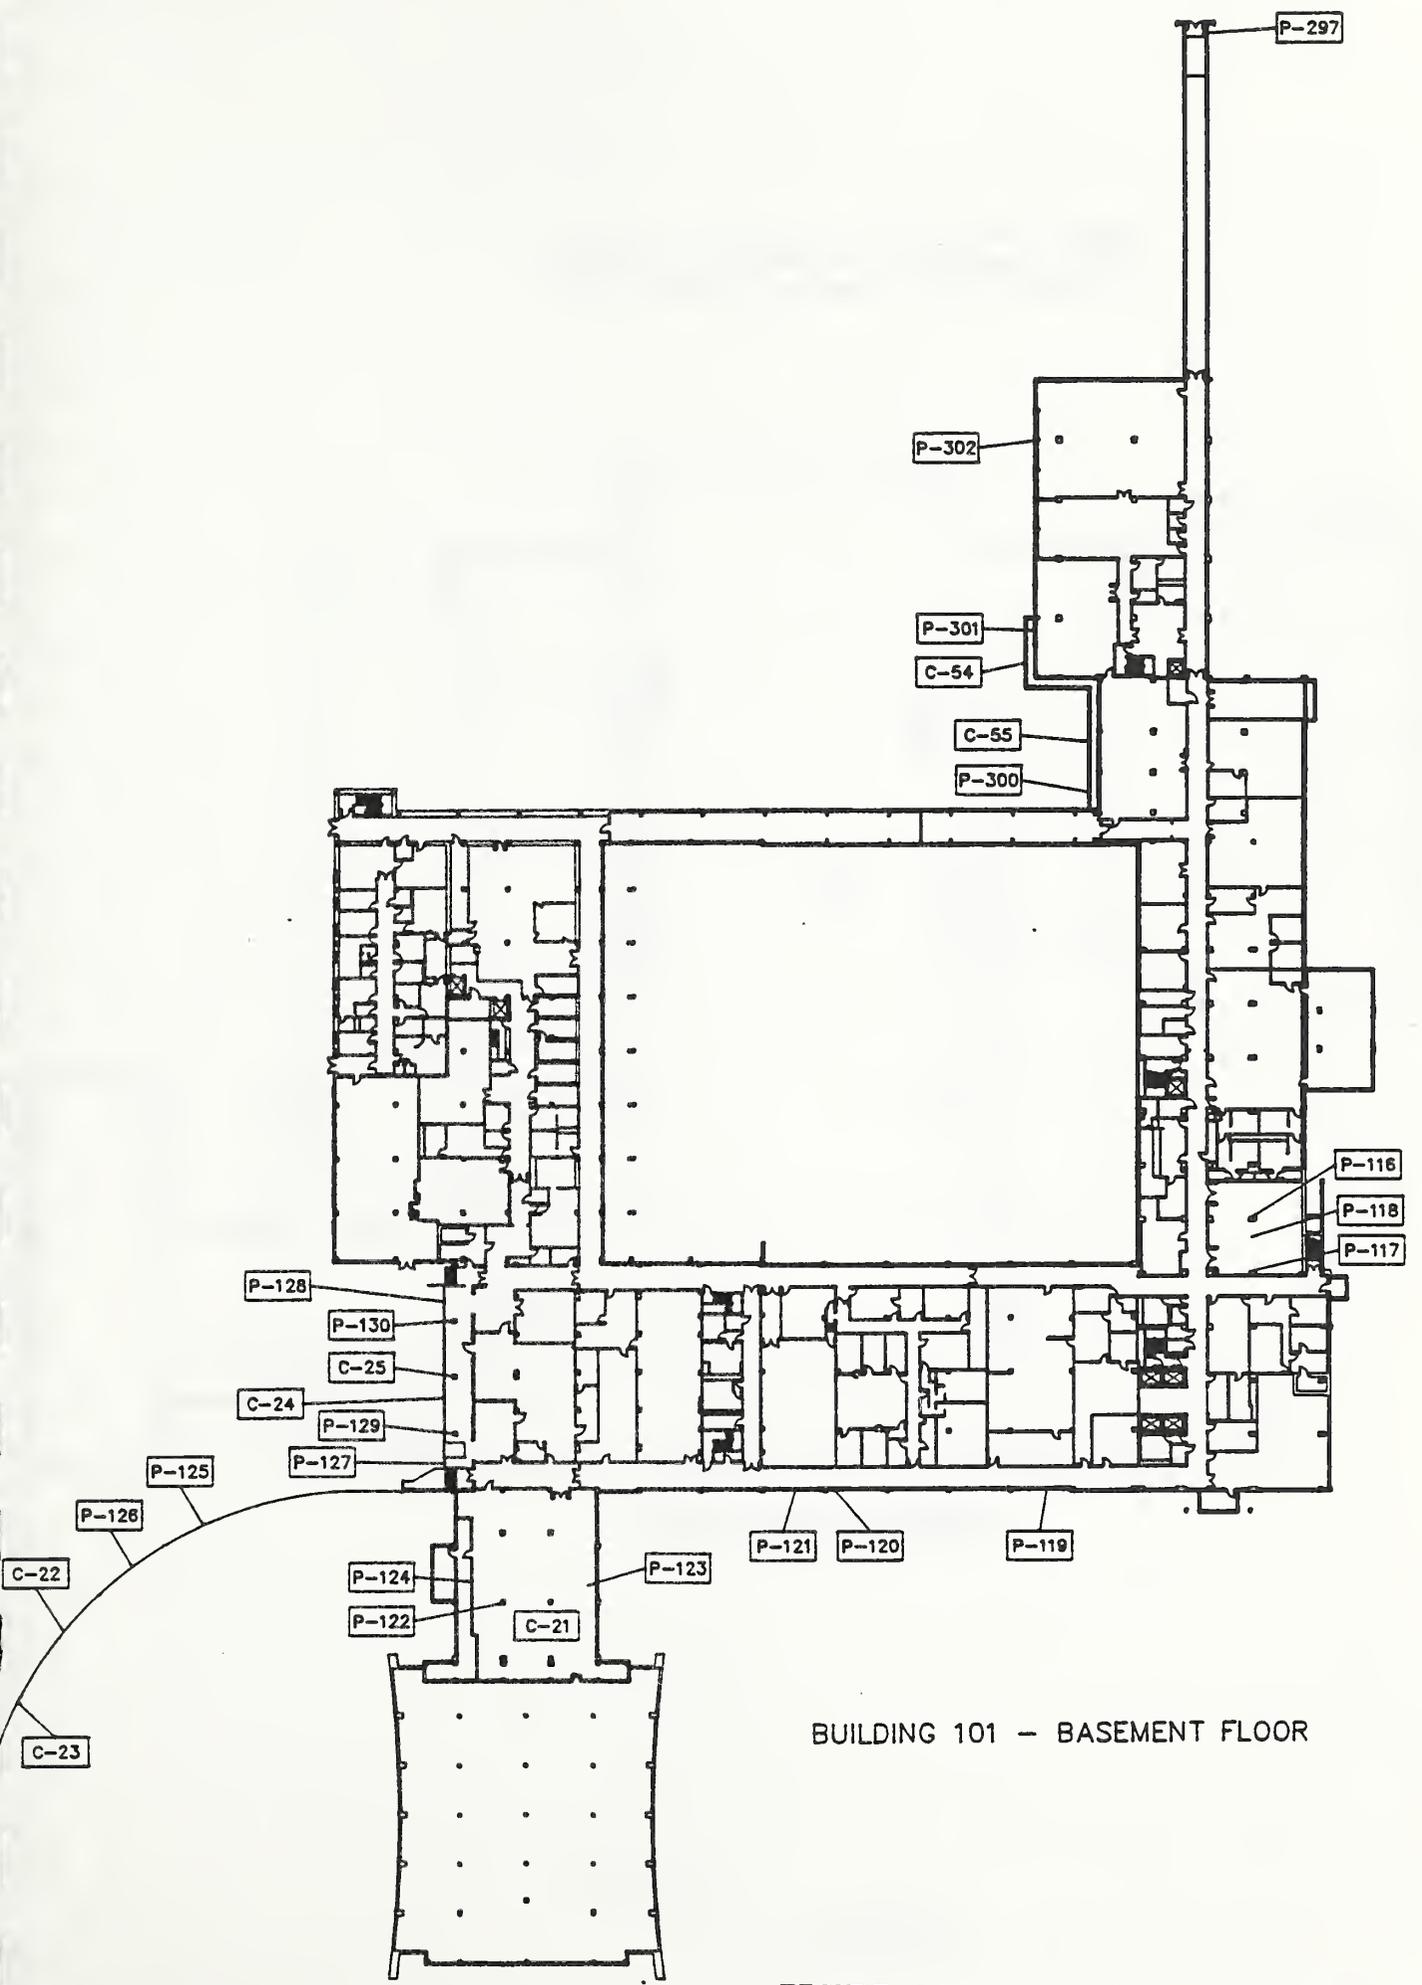
FIGURE 1

PERIMETER FOUNDATION WALLS WERE SURVEYED WHERE SOME AREAS OF DELAMINATION, MINOR CRACKING AND INSUFFICIENT REINFORCEMENT CONCRETE COVER WERE OBSERVED.

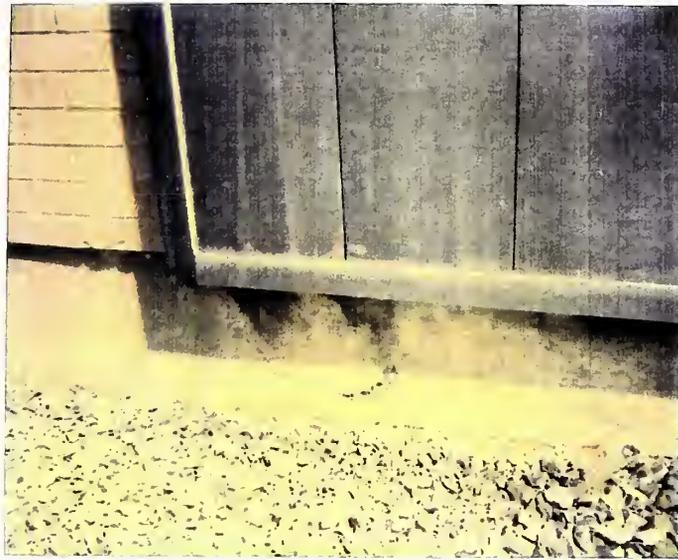
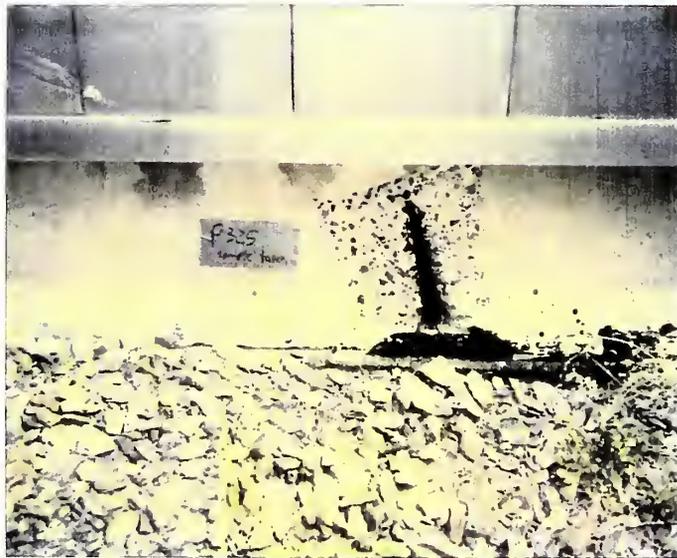
FIGURE 76

BUILDING 245 - WEST EXTERIOR FOUNDATION WALL

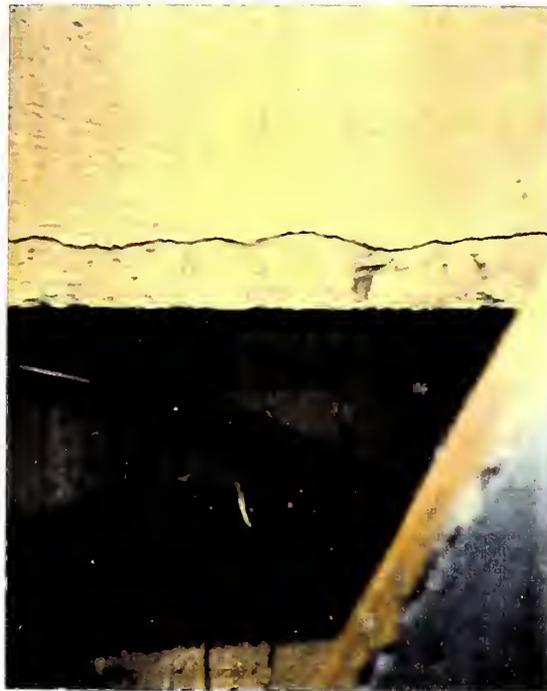
FIGURE 80

TELEPHONE MANHOLE 13: CRACK AT BOTTOM OF ACCESS HOLE

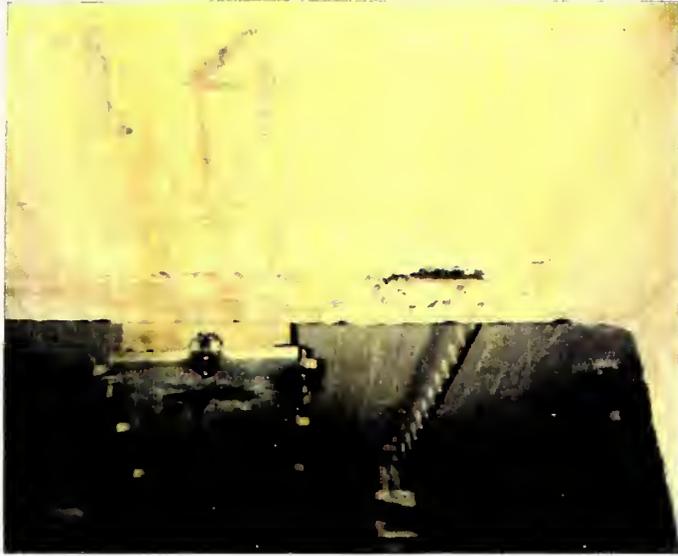
SIGNAL MANHOLE 14: ACCESS HOLE, CRACKING, SPALLING, AND DELAMINATION

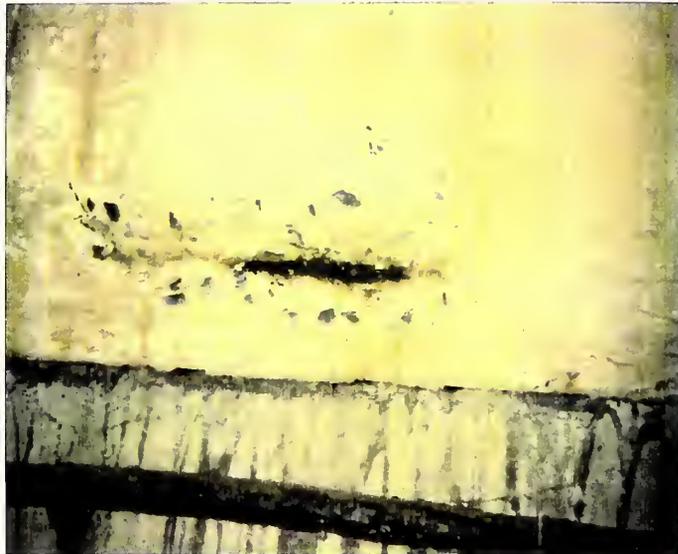
FIGURE 83

SIGNAL MANHOLE 14: ACCESS HOLE, CRACKING AND EXPOSED CORRODED REINFORCEMENT

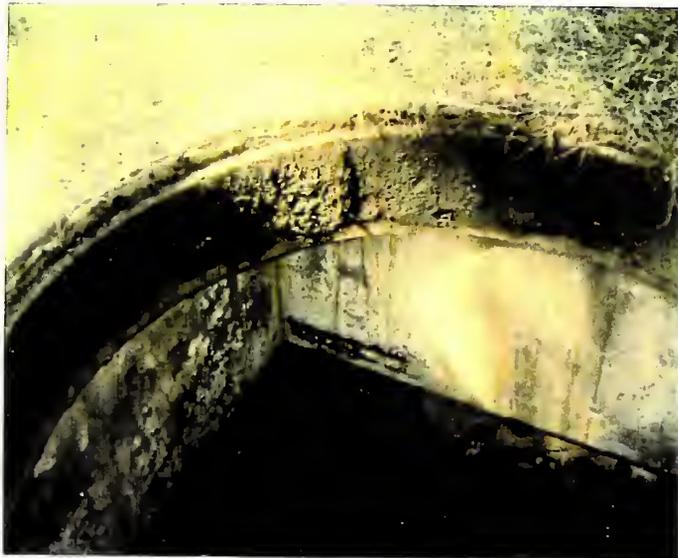
FIGURE 85

SIGNAL MANHOLE 38: EXPOSED REBAR/DELAMINATION AT ACCESS HOLE

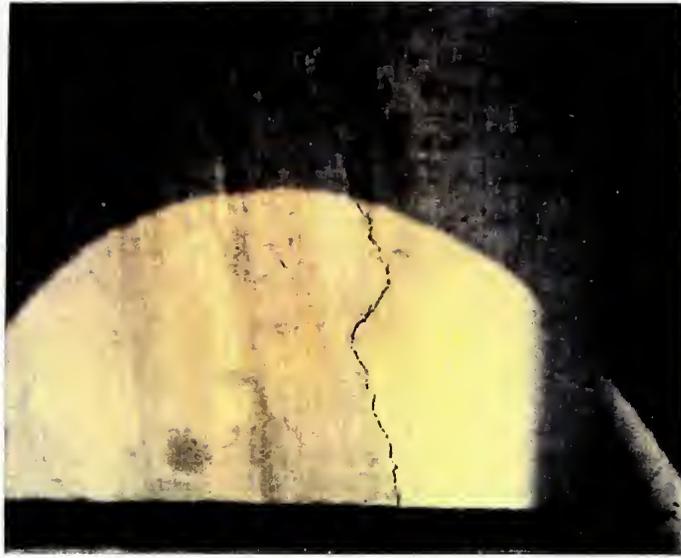
FIGURE 94

As was shown in Manhole # 67 (Tables 2 and 3), underground structures, such as electric, signal, telephone, and steam manholes which are subjected to vehicular traffic, including trucks, deserve additional attention. It is recommended that at least several structures be investigated which are subjected to truck traffic to determine the severity of the loading due to vehicular traffic. Decisions to repair or replace manholes should take into account loading due to vehicular traffic.

TELEPHONE MANHOLE 67: CRACK IN NORTH WALL (UPPER)

TELEPHONE MANHOLE 67: CRACK IN NORTH WALL (LOWER)

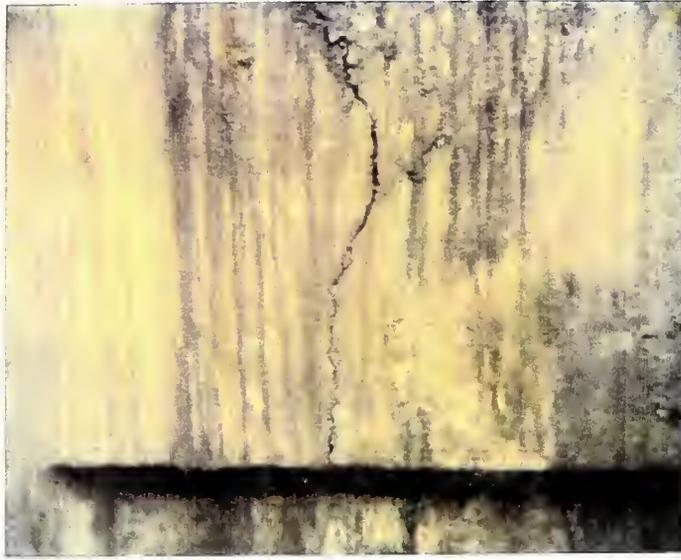
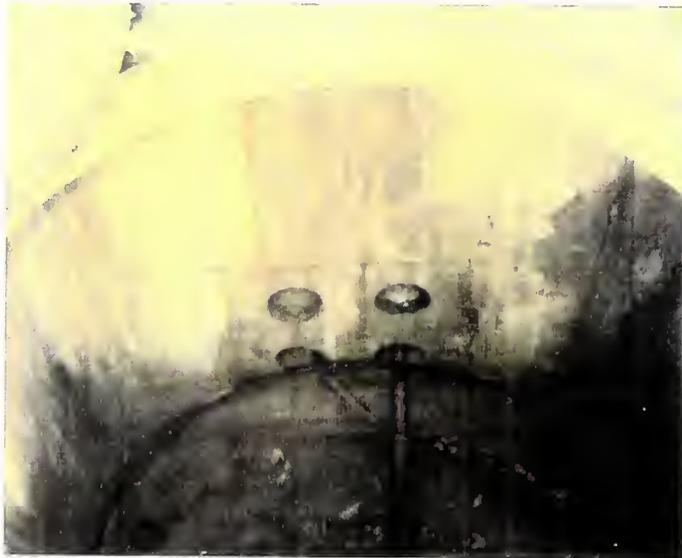
FIGURE 95

TELEPHONE MANHOLE 67: CRACK IN SOUTH WALL (UPPER)

TELEPHONE MANHOLE 67: CRACK IN SOUTH WALL (LOWER)

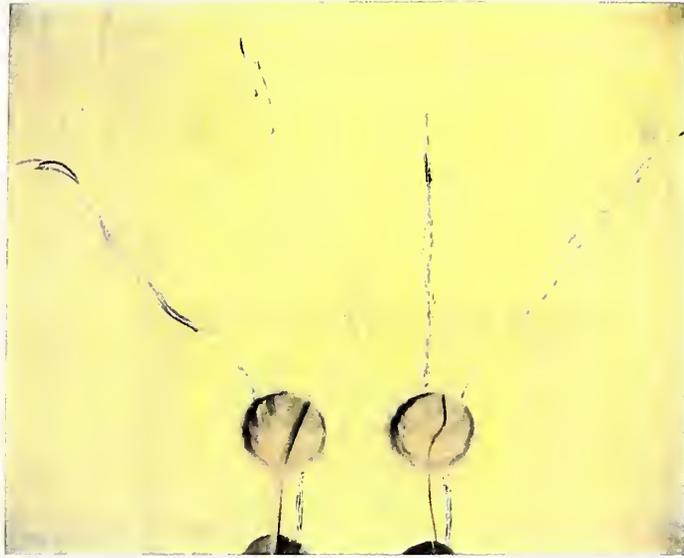
FIGURE 96

SIGNAL MANHOLE 67: CRACKS IN SOUTH WALL (UPPER) - INK USED ON PHOTO TO ENHANCE CRACKS

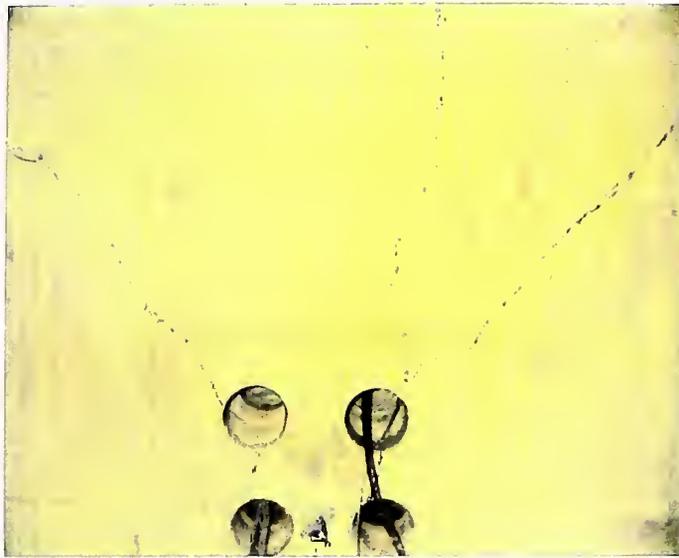
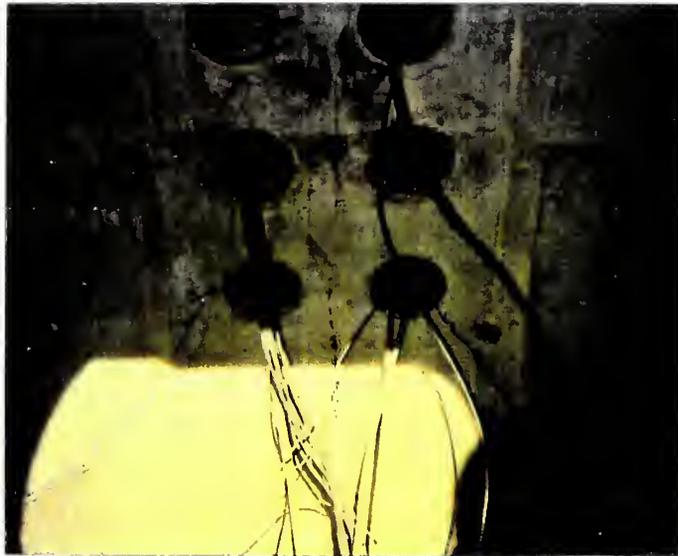
FIGURE 97

SIGNAL MANHOLE 67: CRACKS IN NORTH WALL (UPPER) - INK USED ON PHOTO TO ENHANCE CRACKS

SIGNAL MANHOLE 67: CRACKS IN NORTH WALL (LOWER) - INK USED ON PHOTO TO ENHANCE CRACKS

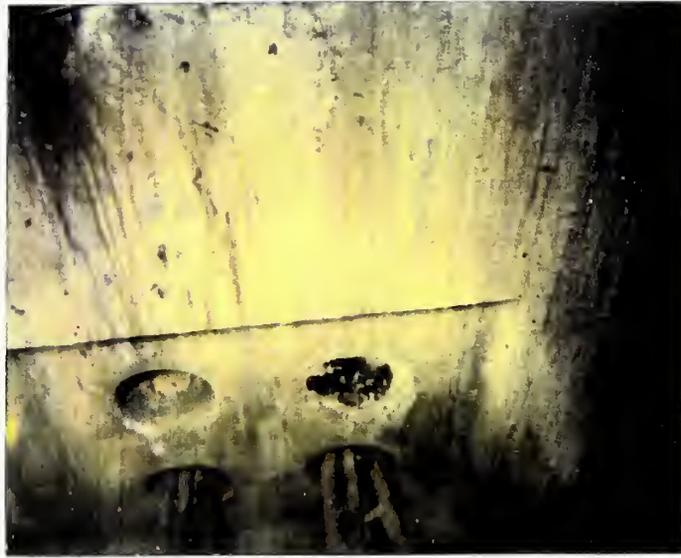
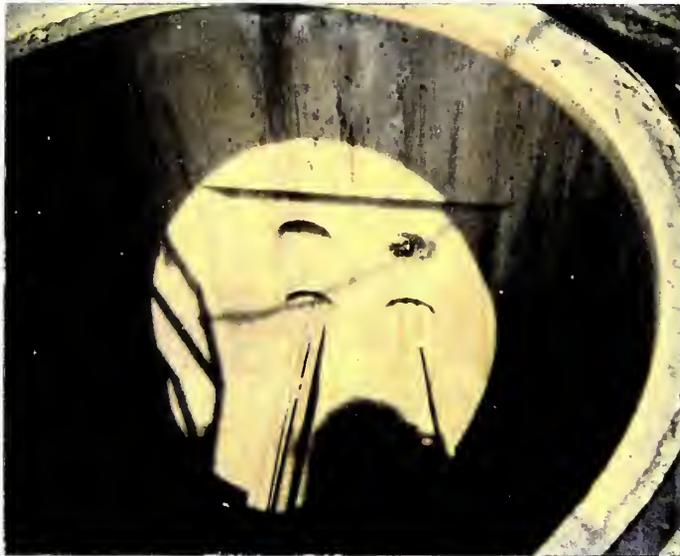
FIGURE 98

ELECTRIC MANHOLE 67: CRACKING IN NORTH WALL (UPPER)

ELECTRIC MANHOLE 67: CRACKING IN NORTH WALL (LOWER)

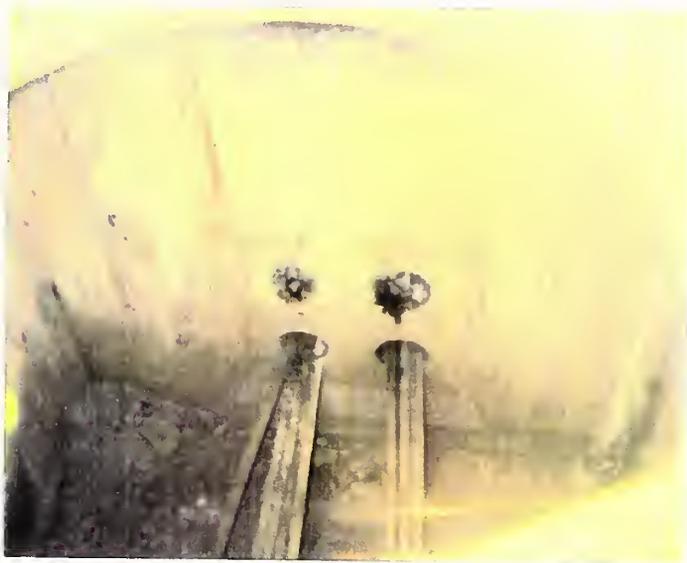
FIGURE 99

ELECTRIC MANHOLE 67: CRACKING IN SOUTH WALL (UPPER)

ELECTRIC MANHOLE 67: CRACKING IN SOUTH WALL
